## **SECTION I – INTRODUCTION**

The Platform Hillhouse is located approximately 5.5 miles offshore in the Santa Barbara channel on the Outer Continental Shelf (OCS) just southeast of Santa Barbara, California (refer to Google Earth Image A below and Photograph 1). The Platform Hillhouse was installed on November 26, 1969, and began production on July 21, 1970. It is located in the Dos Cuadras Field on federal lease OCS-P-0240 and is situated in 190 feet of water. In 1997 Nuevo took over the operations of the platform from Unocal. In 2004, Nuevo was acquired by Plains Exploration and Production (Plains), who took over operation of the platform. Plains only ran the platform for a little more than four months and then sold the operation to DCOR in March 2005. Since March 2005, DCOR took over operational control of the Dos Cuadras field including Platform Hillhouse.

**Platform Hillhouse- Marine Sanitation Device (MSD) Inspection: 2014**

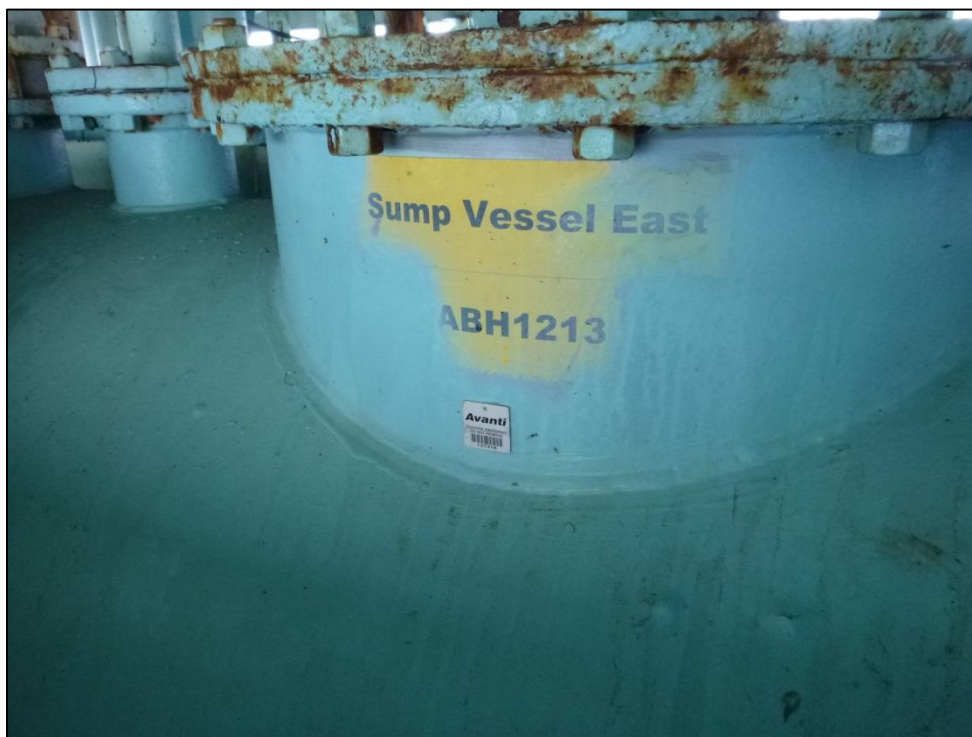
We observed the sump tank/vessel (refer to Photograph 2) located on the sump deck. We observed what appeared to be an active petroleum product leak from the pipe connection to the sump tank/vessel, which was actively running down the sides of the tank (refer to Photographs 15 and 16).

**Photograph 2.** View of sump tank/vessel located on the sump deck, which temporarily stores deck drainage and fire control system water prior to being commingled with the produced water treatment train.

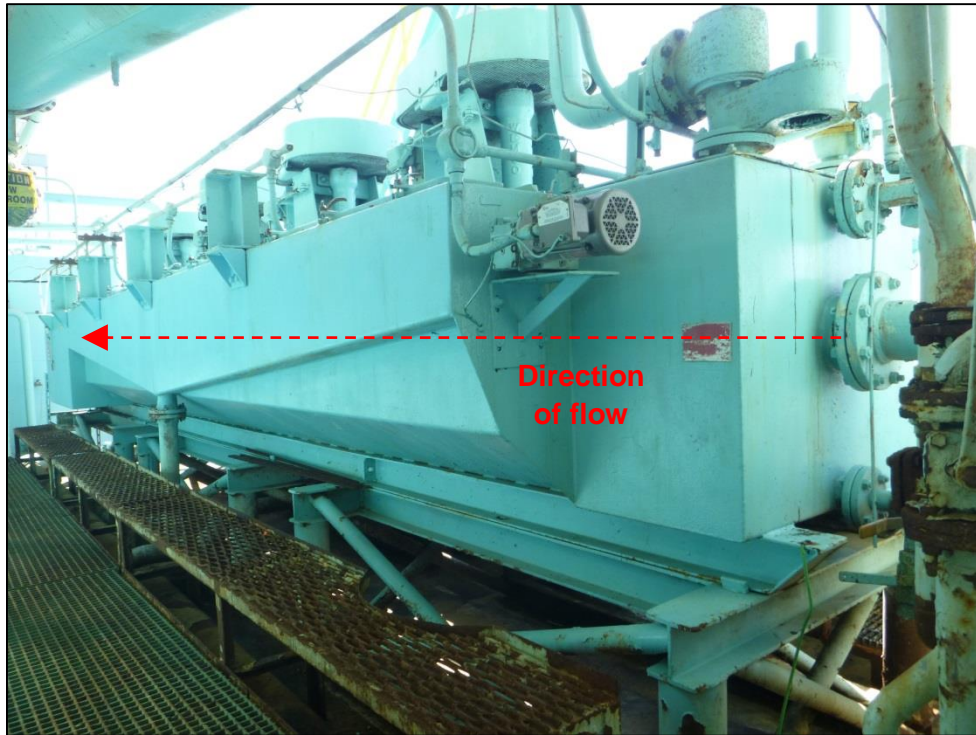
WEMCO units were in use and operational at the time of the inspection (refer to Photograph 5). Following the WEMCO units, produced water is directed to a surge tank and then discharged to the Pacific Ocean via a 90 foot submerged outfall. It should be noted that the Facility deck drainage (Discharge 004) and fire control system water (Discharge 008) are “commingled” with the produced water treatment train at the WEMCOs. The Discharger provided a process flow diagram of the produced water oil/water conveyance and treatment system (refer to Exhibit 1).

**Photograph 5.** View of one of two mechanical WEMCO oil and water separators used at the platform.

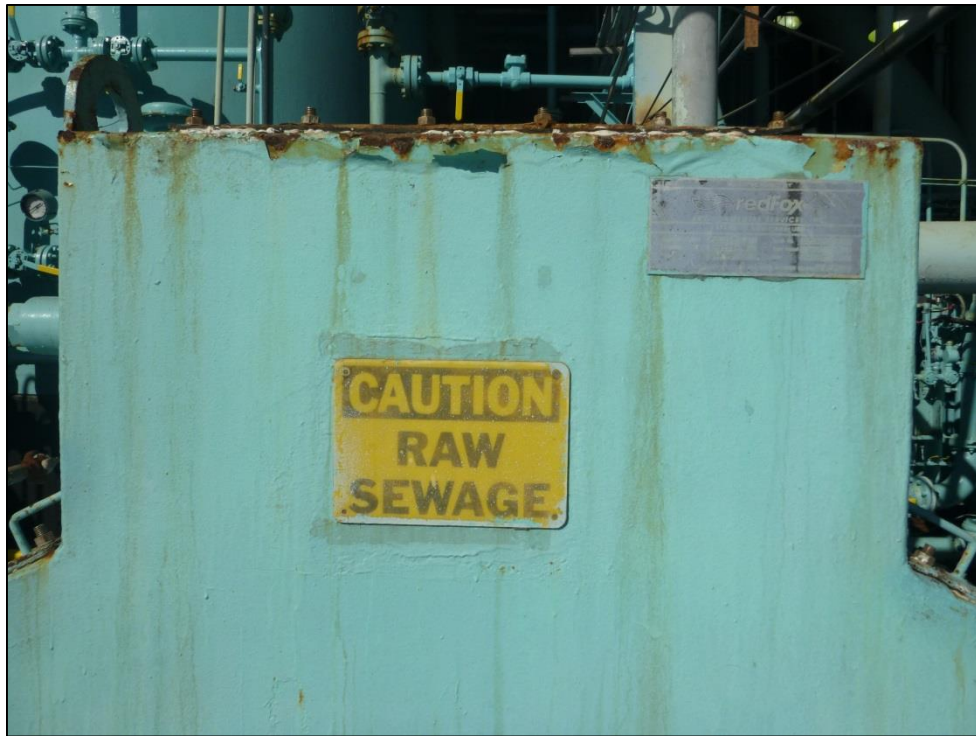
We observed the Facility redFox® MSD used to treat sanitary (black water) wastes (Discharge 005) prior to being discharged to the Pacific Ocean (refer to Photographs 6 and 7). The redFox® MSD unit was stamped with a manufacture date of July 2, 1997.

Based on a review of the Discharger's 2014 and 2015 annual Facility MSD inspection records (refer to Exhibit 3), we observed that the MSD unit did not meet total and fecal coliform USCG "appropriate standards" for MSD effluent per 40 CFR Part 140.3(d) for samples collected on December 15, 2014 (refer to Exhibit 4 Page 2). Specifically, the Discharger's contract laboratory analytical results for the MSD effluent samples collected on December 15, 2014, for total coliform and *E.coli* were greater than 24,000

We also noted that the Discharger had not inspected the internal media bed and media chambers annually as stated in the manufacturer's specifications. We also observed in the Discharger's 2014 and 2015 annual Facility MSD inspection reports that inspections of the MSD unit's interior was not performed due to "bolted hatches" (refer to Exhibit 3 Page 2). However, the redFox® FoxPac manufacturer installation, operation, and maintenance manual obtained from redFox® post-inspection recommends that the interior media bed and media chamber be inspected and cleaned annually. It was unclear if the Discharger performed the recommended media bed and media chamber inspection and cleaning for the MSD unit in accordance with manufacturer's recommendations and the proper operation and maintenance provision of the Permit. Specifically, the Discharger's 2014 and 2015 annual Facility MSD inspection reports stated that the interiors were not inspected; however, the report stated that the unit was cleaned in April 2014 and March 2015. It was not clear to us how the MSD unit was cleaned if the media and disinfection chambers were not inspected.

**Photograph 6.** View of the redFox® environmental marine sanitation device (MSD) Fox Pac Model No. RF-1000-FP, Serial No. 3709 used to treat domestic and sanitary wastes.

It should be noted that in response to the USCG appropriate standard exceedance of total coliform and *E.coli* parameters in 2014, the Discharger recommended (refer to Exhibit 3 Page 2) increasing the total chlorine residual to 4 to 5 parts per million (ppm) within the MSD unit disinfection chamber. It should be noted that based on our review of the Discharger's 2015 annual Facility MSD inspection and associated contract laboratory analytical results, the Facility MSD unit did not exceed the USCG appropriate standards for total coliform and *E.coli* in 2015.

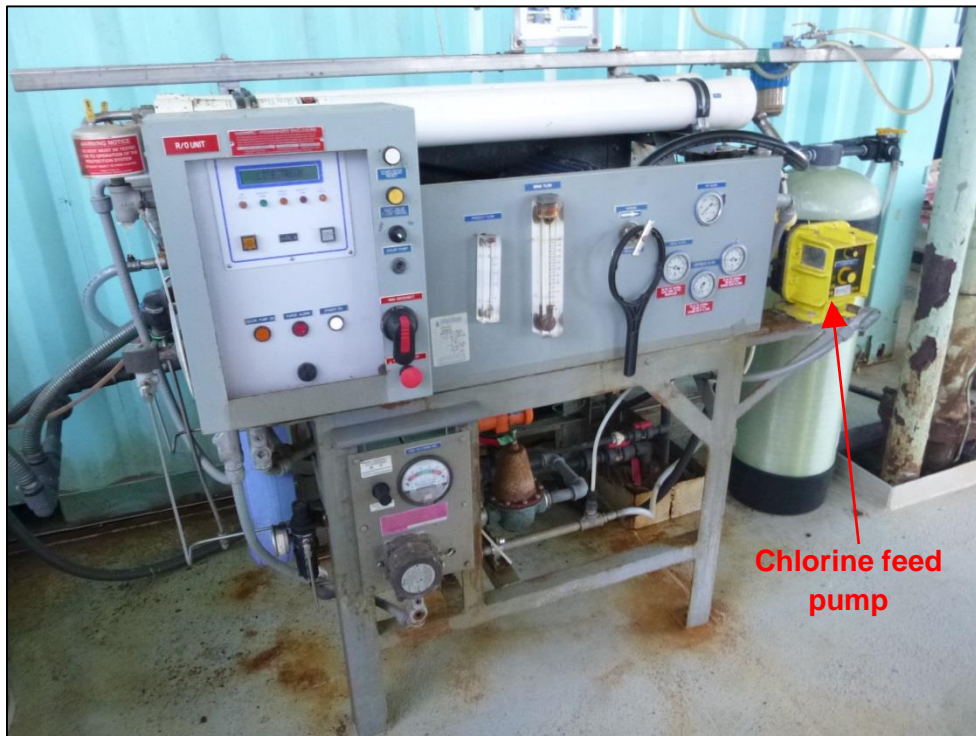
We observed the desalination unit and waste stream discharge location (Discharge 007) at the time of the inspection (refer to Photographs 8 and 9). Because the desalination unit was not in use at the time of the inspection, it was unknown if the Discharger conducted daily daylight hour monitoring by visual observation (for foam or floating solids) in the vicinity of the desalination unit waste stream discharge (Discharge 007) when the desalination unit was in use.

We observed that the Facility representatives were not familiar with the frequency of the desalination unit's use or the associated waste stream discharges to the Pacific Ocean (Discharge 007). Because the desalination unit was not in use at the time of the

inspection, it was also unknown if the Facility conducted daily daylight hour visual observation monitoring and recordkeeping of the desalination unit waste stream when in use. The desalination unit (refer to Photographs 8 and 9) was in standby mode during the Facility walk through.

**Photograph 8.** View of the desalination (i.e., reverse osmosis) unit located on the drill deck. According to onsite Facility representatives, the desalination unit is periodically used to provide water for sinks and showers on the platform.

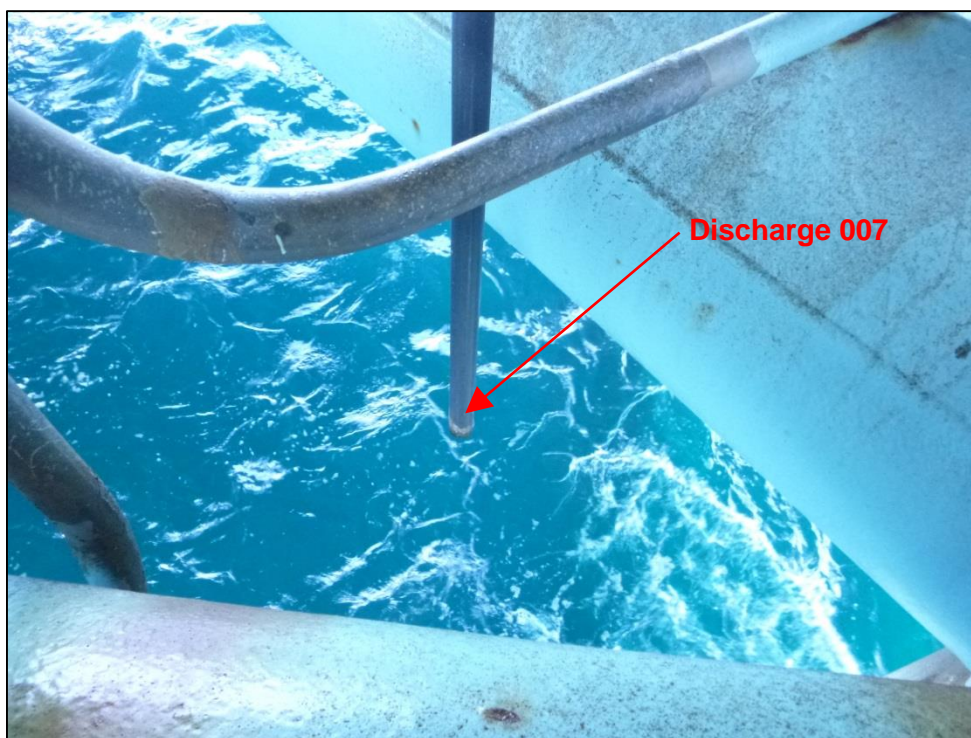
**Photograph 9.** View of the desalination (i.e., reverse osmosis) unit wastes discharge point (Discharge 007) to Pacific Ocean.

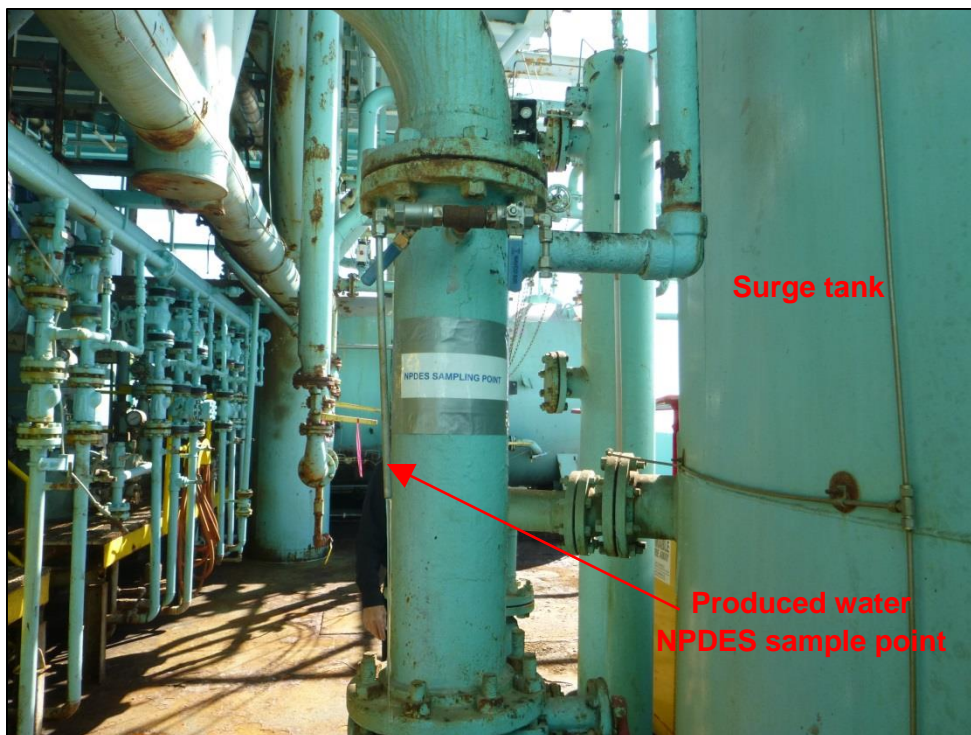
During the Facility walk through, we observed the Facility's produced water treatment train. The Discharger's produced water (Discharge 002) NPDES sampling point is located at the discharge pipe off of the surge tank. We viewed this discharge pipe as a component of the inspection (refer to Photograph 10). Based on our observations during the inspection, the produced water NPDES oil and grease sample location appeared to provide representative samples. The receiving water (Pacific Ocean) within the vicinity of the produced water discharge pipe was viewed and observed to be free of visually objectionable characteristics at the time of the inspection (refer to Photograph 11). Mr. Romp stated that the Facility has the ability to bypass the WEMCO units, if needed like in instances of high produced water production. Facility representatives stated that in these instances the produced water is routed via pipeline to the Discharger's onshore Rincon Treatment Facility during a bypass. Facility representatives stated that the last known bypasses of the Facility WEMCOs occurred during the previous Permit period on:

**Photograph 10.** View of produced water (Discharge 002) NPDES sampling point located off of the discharge pipe from the surge tank.

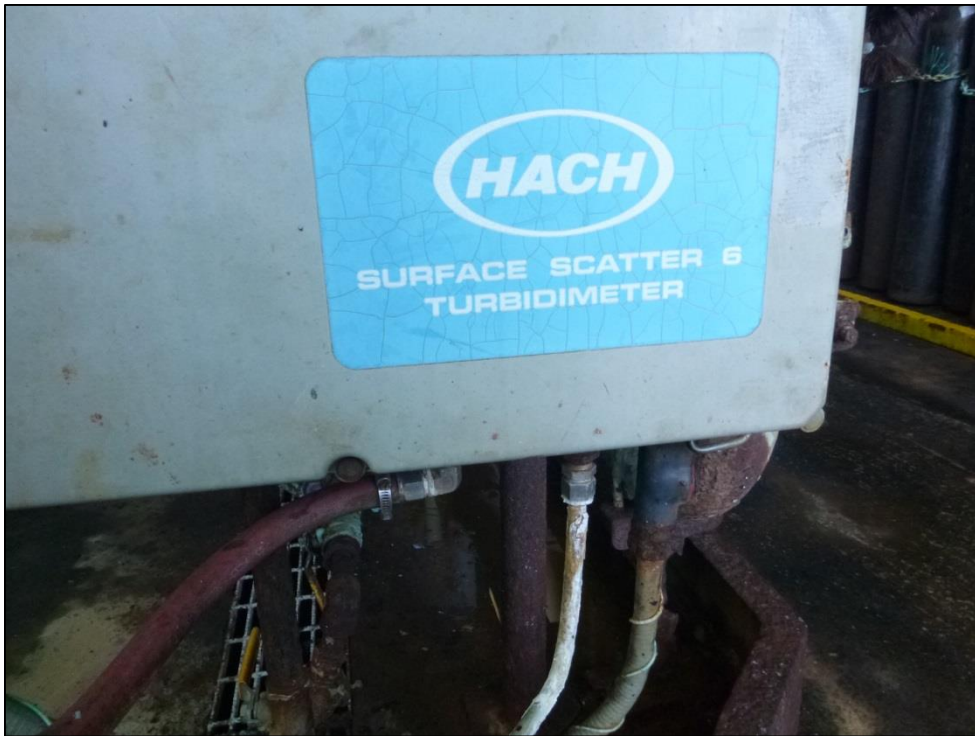
We observed the Facility on-line oil and grease monitor, which was installed in accordance with Part II.G.6, On-Line Oil and Grease Monitors, requirements of the Permit. The Discharger conducts additional internal process monitoring for oil and grease in produced water after the surge tank via continuous inline turbidity measurement utilizing a HACH Surface Scatter® 6 sc turbidimeter (refer to Photographs 12 and 13). At the time of the inspection, we observed the continuous inline turbidity measurement of produced water to be 1.59 nephelometric turbidity units (NTUs). The Facility representatives stated that there is an alarm (visual and audible) that

activates when the inline turbidity monitor exceeds 15 NTU and 20 NTU. The Facility representatives stated that these set points were to ensure the produced water (Discharge 002) did not exceed the monthly average and daily maximum oil and grease Permit effluent limits of 29 mg/L and 42 mg/L, respectively. The Facility representatives said the set points were developed based on Facility-specific correlation between the turbidity monitor and oil and grease measurements. The Discharger calibrates the inline turbidimeter quarterly in accordance with manufacturers' recommendations. During the inspection, we confirmed that the Discharger was performing the calibrations using the cylinder method with a 4,000 NTU formazin solution (refer to Photograph 14). Facility representatives provided documentation for the inline turbidimeter calibrations that were conducted on March 26, 2015, May 26, 2015, August 27, 2015, November 21, 2015, and February 14, 2016.

**Photograph 12.** View of continuous inline turbidity measurement device, a HACH Surface Scatter® 6 sc turbidimeter. The Discharger uses this to comply with Part II.G.6, On-Line Oil and Grease Monitors, of the Permit.

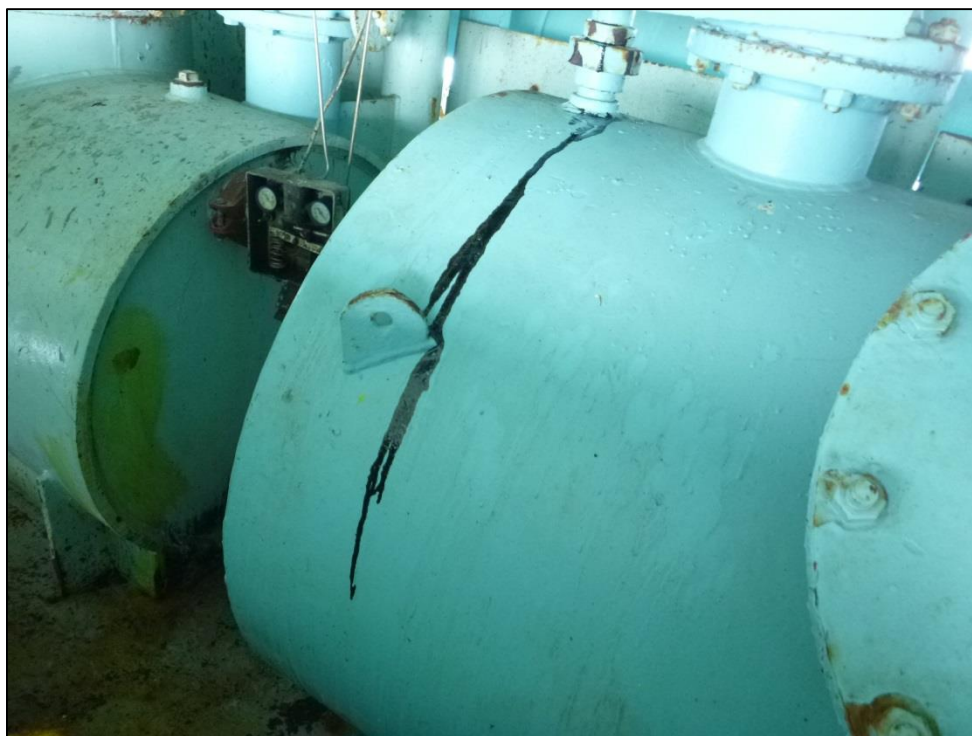
- a. We observed what appeared to be an active petroleum product leak from a pipe connection running down the side of the sump tank/vessel (refer to Photographs 2, 15, and 16). The sump tank/vessel receives deck drainage and fire control system water prior to being pumped into the onsite repurposed platform Henry treater, now known as the settling tank (refer to Photograph 3). The deck drainage and fire control system water are subsequently commingled with the produced water treatment process just upstream of the WEMCO units. This petroleum product leak was not cleaned up or remediated at the time of the inspection.

**Photograph 15.** View of petroleum product leak from pipe connection to sump tank/vessel, shown in Photograph 2.

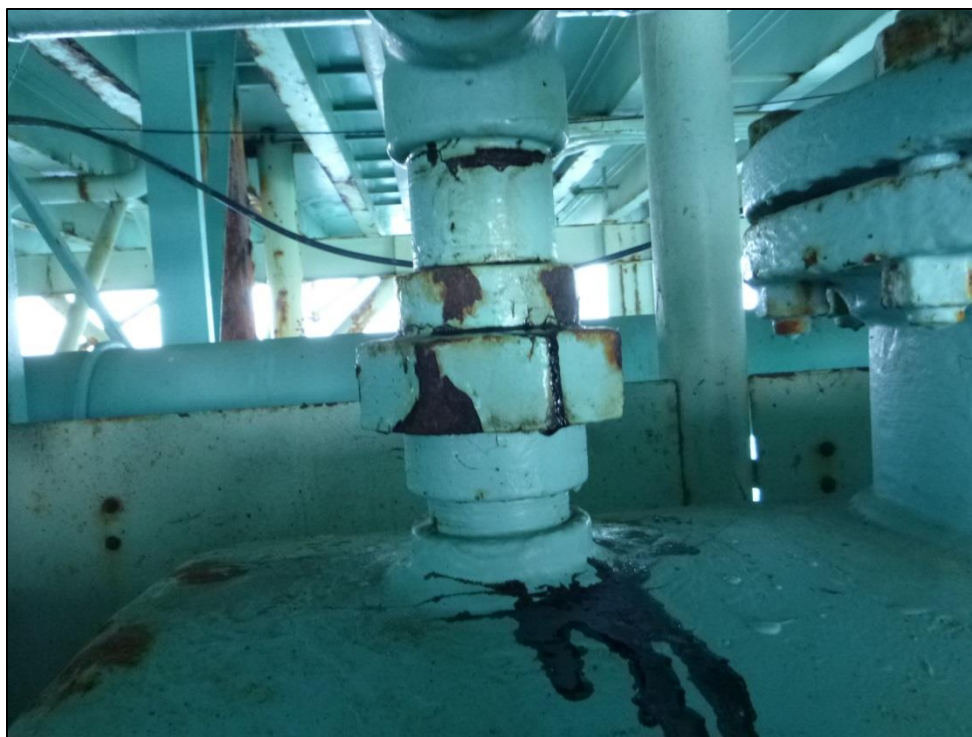
**Photograph 16.** Close-up view of petroleum product leak on pipe connection to sump tank/vessel, shown in Photograph 15.
